Watershed Restoration FACTSHEET:

Stream Valley Drive Project

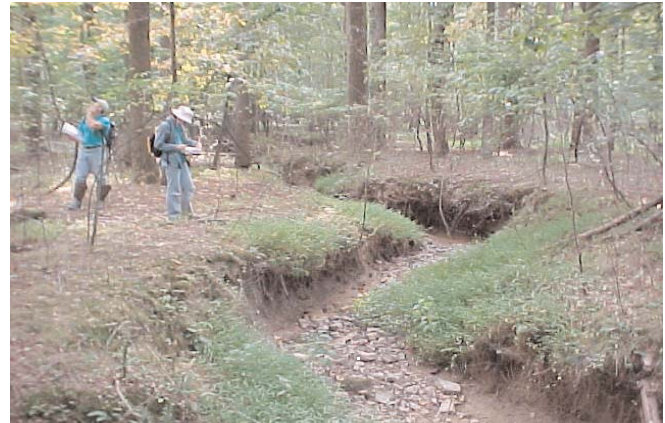
Pre-restoration conditions included severely eroded stream banks, and undercut trees,

The project attempted to save undercut stream bank trees with supportive rock packing.⁹ Seriously damaged trees were flush cut, allowing root systems to remain in the bank for stabilization.

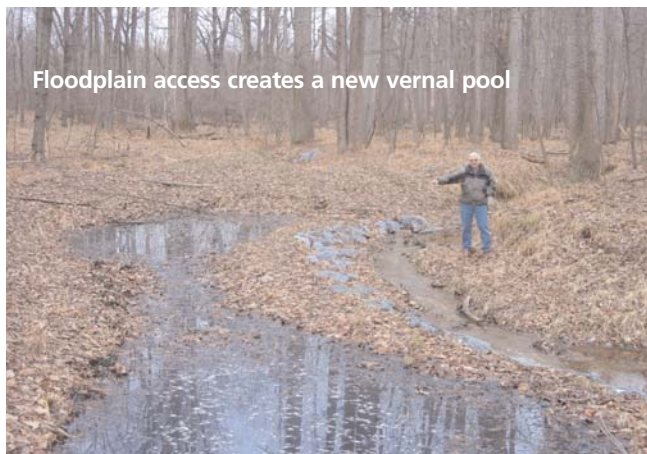
Floodplain access creates a new vernal pool

Stream access to the original floodplain has created a new backwater vernal pool, an important habitat feature for amphibians and other aquatic plants and animals.

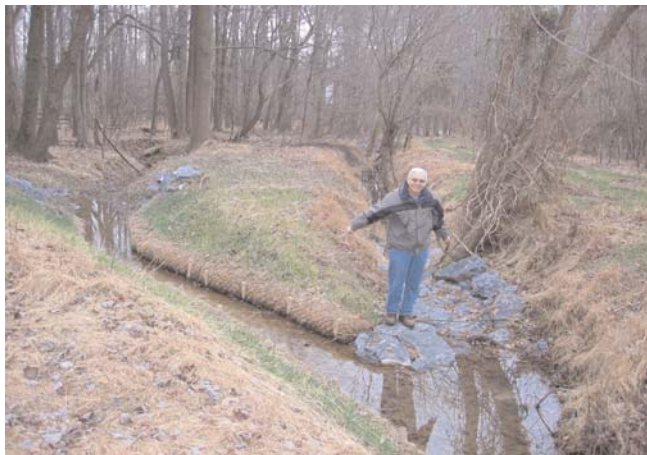
The stream is directed back to its original channel (left), away from the straightened, entrenched channel constructed as a result of Fieldcrest Road construction.

The original stream below Fieldcrest Road had been diverted away from its natural channel into a straightened, entrenched ditch dur-

ing road construction. The restoration project returned the stream to its original, gently meandering path, and left the straightened channel in place for storm overflow, with installed rock weirs, which created pools for additional wetland habitat.

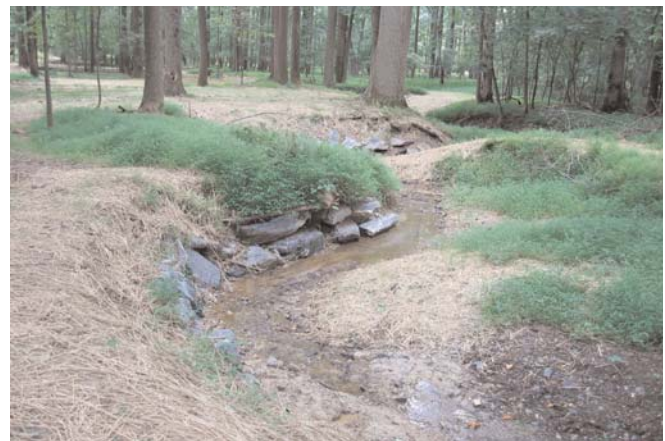
Rock stabilizes the toe of the stream bank slope, which has also been graded back to create access to a floodplain. This allows the erosive energy from high storm flows to dissipate.

Rock installed at the toe of the stream bank slope stabilized the area of the stream channel subject to the greatest erosive or "shear" stress. The slopes above the reinforced toes were graded back to create new floodplain terraces, which allow high flows to lose erosive energy by escaping the confined stream bank.
